LESSONS FROM HISTORY - POOR WEATHER OPS

Reproduced from the Airship Association Conference Proceedings of 2004, presented by Norman Mayer

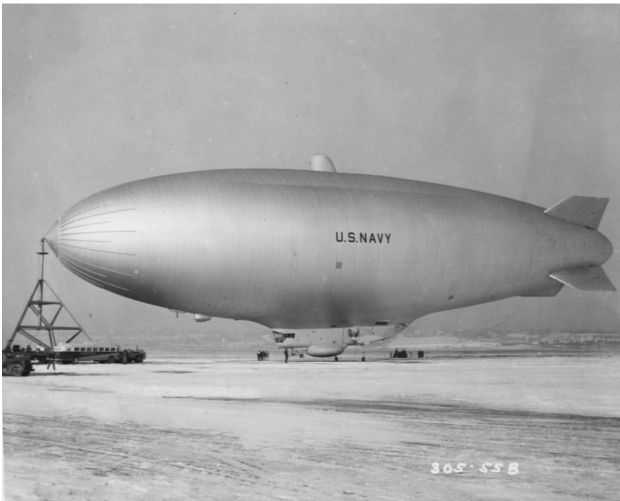
All flights were made with ZPG-2 and 2W airships from NADU and squadron ZW-1, based at N.A.S. Lakehurst. ZPG-2 and 2W specifications are shown below. A ZPG-2W airship is pictured on this page. Ten initial flights were flown by NADU airships during the winters of 1954, 55 and 56.

ZPG-2 & 2W Airship Characteristics

Length: 342.7 ft
Height: 94.7 ft
Width: 75.4 ft
Envelope Vol: 975,000 cu ft (finess Ratio 4.5)
Gross Weight: 66,400 lbs (max lift: 6000 lbs)
Max Speed: 70.5 kts
Endurance @ 40 kts: 54 hrs
